# **INDOOR AIR QUALITY ASSESSMENT**

**Manchester Memorial Elementary School Annex  
43 Lincoln Street  
Manchester-by-the-Sea, Massachusetts**

Prepared by:  
Massachusetts Department of Public Health  
Center for Environmental Health  
Bureau of Environmental Health Assessment  
Emergency Response/Indoor Air Quality Program  
September 2004

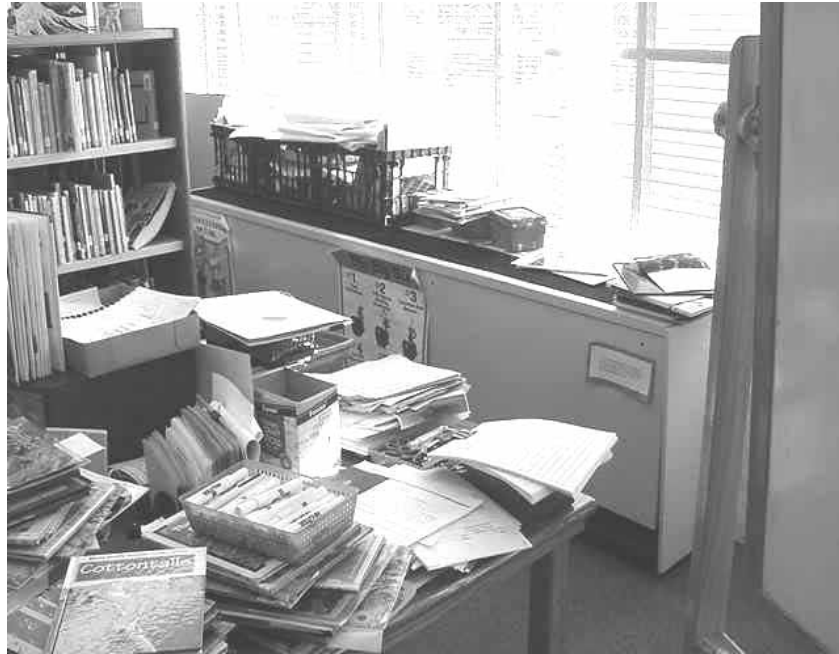
**Picture 1**

Fresh air in library is supplied by a unit ventilator (univent) system (Picture 1). Univents are designed to draw air from outdoors through a fresh air intake located on the exterior wall of the building and return air through an air intake located at the base of each unit ([Figure 1](#)). Fresh and return air are mixed, filtered, heated and provided to

library through a fresh air diffuser located on the front of the unit. Univents were found deactivated, which prevents a continuous source of outside air to provide ventilation. Obstructions to airflow, such as books and paper on top of the univent fresh air diffusers were also observed. In order for univents to provide fresh air as designed, univent air diffusers and return vents must remain free of obstructions. Importantly, these units must be activated and allowed to operate during school occupancy.

**Items on Unit Ventilator**

1. Examine each univent for function. Survey the univent function to ascertain if an adequate air supply exists. Consider consulting a heating, ventilation and air conditioning (HVAC) engineer concerning the restoration of univent fresh air control dampers throughout the library.

2. Remove all blockages from univents to ensure adequate airflow. Clean interiors of univents regularly.
3. To maximize air exchange, the BEHA recommends that the ventilation system operate continuously during periods of occupancy independent of library thermostat control.

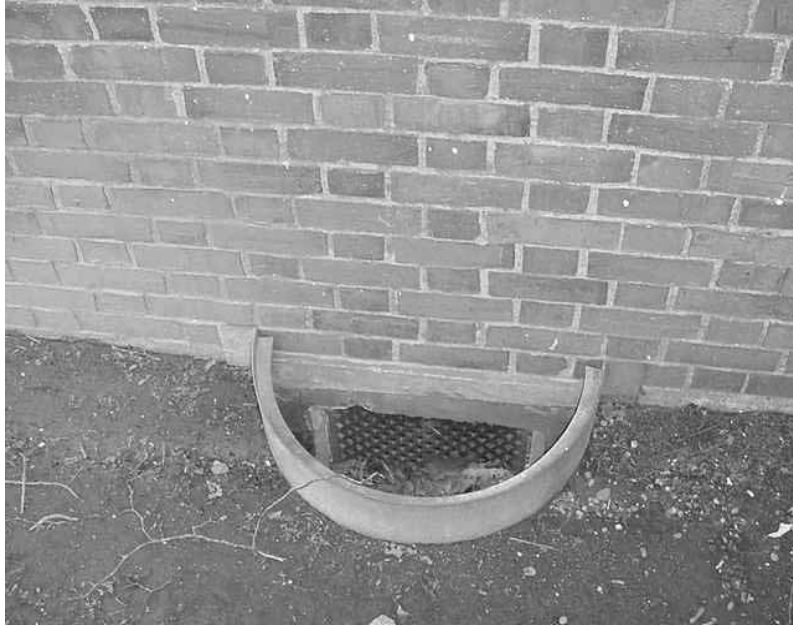
**Picture 2**

The mechanical exhaust ventilation system in the library consists of a grill installed in a metal ductwork. The metal ductwork is connected to an exhaust vent motor below grade, which directs exhaust air from the building via a subterranean grate (Picture 2). The library exhaust system was not operating during the assessment and the vent was blocked with shelving.

**Subterranean Exhaust Vent Grate**

To maximize air exchange, the BEHA recommends that both supply and exhaust ventilation operate continuously during periods of school occupancy. In order to have proper ventilation with a mechanical supply and exhaust system, the systems must be balanced to provide an adequate amount of fresh air to the interior of a room while removing stale air from the room. It is recommended that existing ventilation systems be re-balanced every five years to ensure adequate air systems function (SMACNA, 1994). The date of the last servicing and balancing was not available at the time of the assessment.

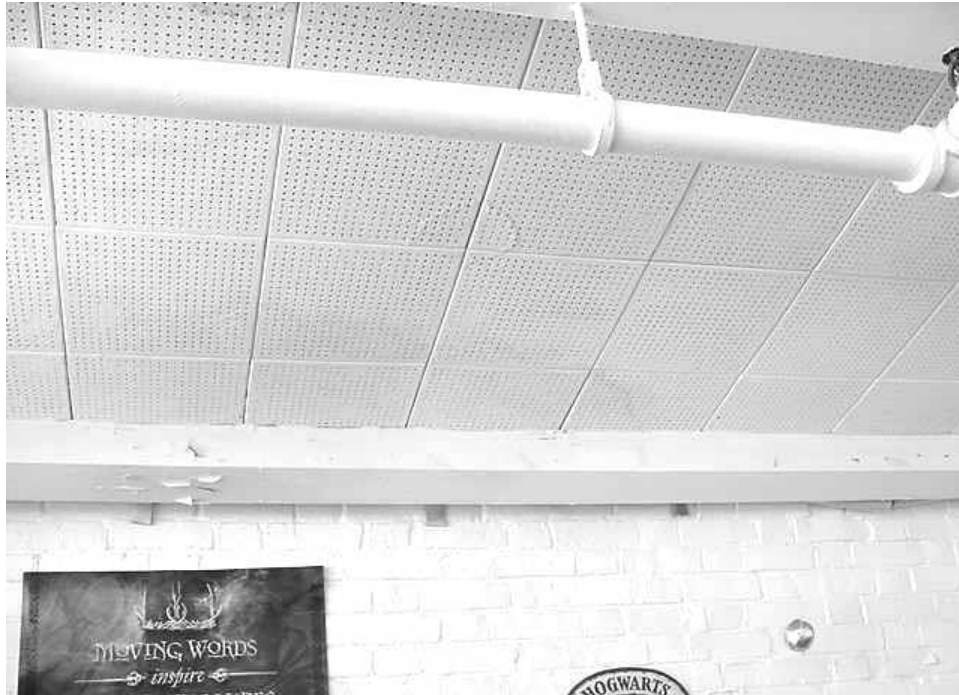
**Picture 3**

Water-damaged ceiling tiles (Picture 3) and gypsum wallboard (Picture 4) were observed in the restroom, indicating water penetration or a plumbing leak. Tiles appear to be directly adhered to the ceiling. Replacement of these types of ceiling tiles is difficult, since their removal appears to necessitate the destruction of the tile, which can result in the aerosolization of particulates. Water-damaged ceiling tiles may provide a medium for mold growth and should be replaced after a water leak is discovered and repaired.

**Water Damaged Interlocking Ceiling Tiles**

1. Examine possible methods to properly seal the wall/roof to prevent further wood deterioration.
2. Examine the feasibility of installing a gutter/downspout system on the roof.
3. Water-damaged ceiling tiles should be replaced. These ceiling tiles can be a source of microbial growth and should be removed. Sources of water leaks (e.g. window frames and roof) should be identified and repaired. Examine the non-porous surface beneath the removed ceiling tiles and disinfect with an appropriate antimicrobial.

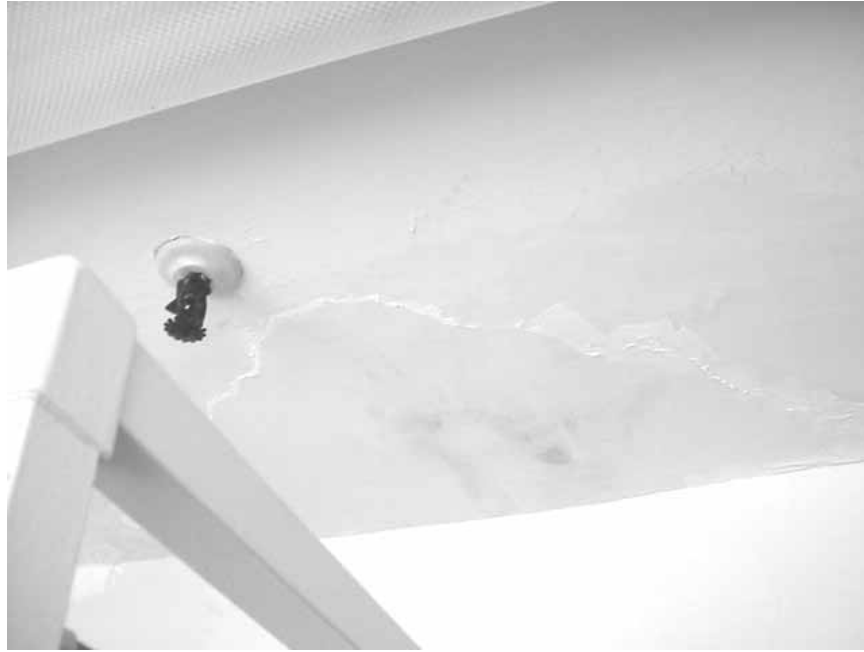
**Picture 4**

**Water Damaged Gypsum Wallboard in Rest Room**

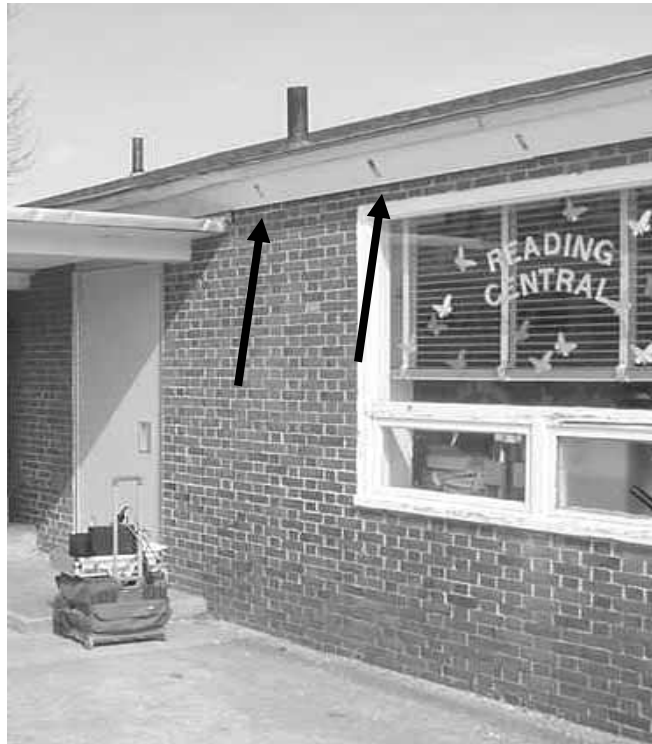
**Picture 5**

The building was originally equipped with a gutter/downspout system, that has since been removed. Areas along the roof soffit have spots of dissimilar/missing paint in an evenly spaced pattern with nail holes, which is likely the location of the gutter brackets (Picture 5). Two pipes in the tarmac that are similar to other downspout drains observed by BEHA staff were seen at the corners of the annex (Picture 6). Without

downspouts/ gutters, water accumulates along the exterior walls of the building, subsequently leading to water penetration into the basement crawlspace through the subterranean exhaust vents.

**Roof Soffit Missing Gutters, Note Breaks in Paint**

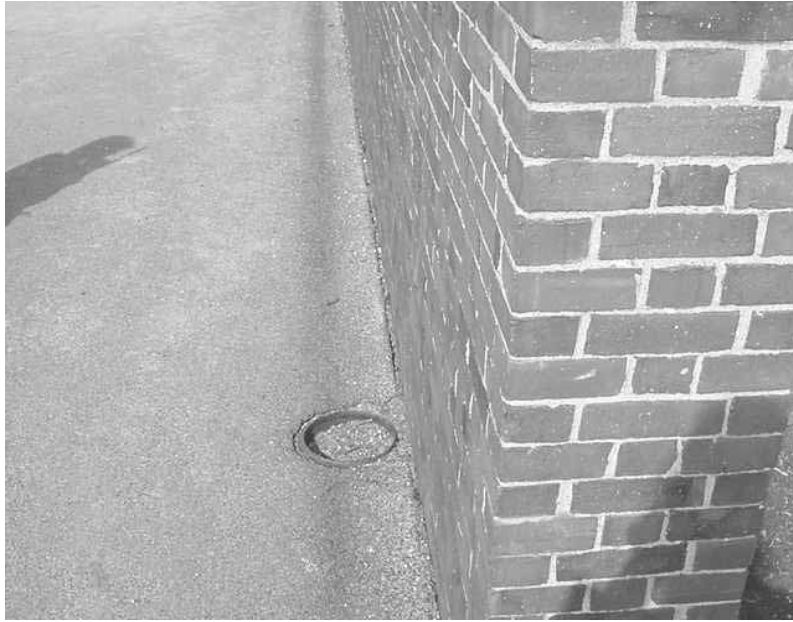
**Picture 6**

**Former Downspout Drain**

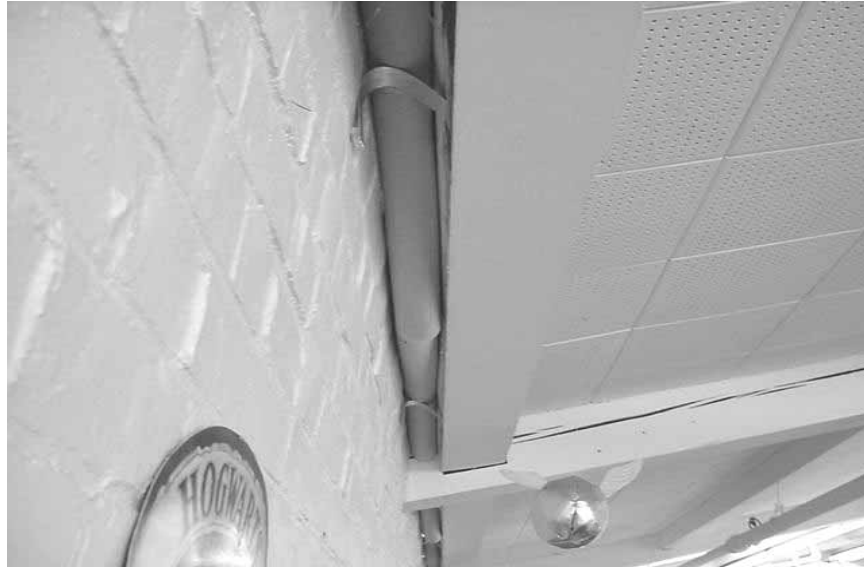
**Picture 7**

Of note were the east and west wall/roof junctions. It appears that pipe insulation had been inserted into a space that exists between the roof and exterior wall (Picture 7). It is likely that this insulation was installed to prevent cold air penetration. Pieces of solid material were seen below the insulation on bookshelves, which on initial inspection, appeared to be consistent with disintegrating wood. If this insulation was placed to prevent drafts, certain cold weather can create conditions that would cause condensation to accumulate in the junction between hot and cold materials. Condensation is the collection of moisture on a surface that has a temperature below the dew point. The dew point is a temperature that is determined by air temperature and relative humidity. As an example, at a temperature of 70° F and relative humidity of 20 percent, the dew point for water to collect on a surface is approximately 27° F (IICR, 2000). Using actual weather data from January 6 to January 31, 2004, the mean temperature in the Manchester-by-the-Sea area was below 27° F twenty-five of the twenty-six days. Therefore, it was likely that materials at the roof/wall junction were generating condensation during this cold weather, which damaged building materials causing the debris seen on top of bookshelves.

**Pipe Insulation Inserted into Space between Roof and Exterior Wall**

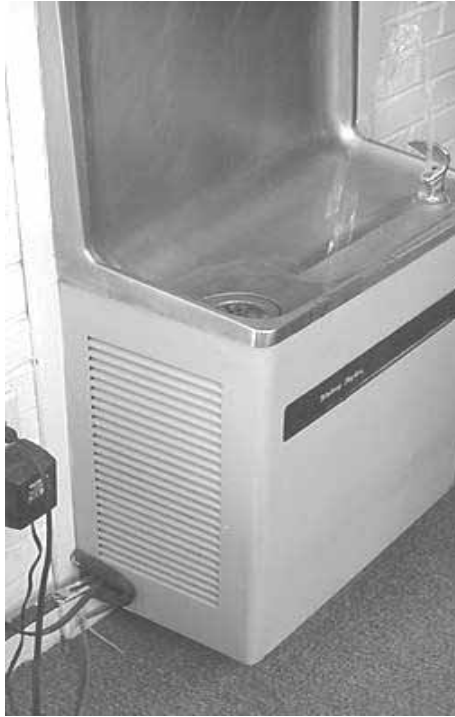
**Picture 8**

A water bubbler was placed over carpeting (Picture 8). The pressure in the bubbler allows water to shoot over the catch basin and onto the floor. Water spillage or overflow can result in the wetting of the carpet. The US Environmental Protection Agency and the American Conference of Governmental Industrial Hygienists (ACGIH)

recommends that porous materials be dried with fans and heating within 24-48 hours of becoming wet (US EPA, 2001; ACGIH, 1989). If porous materials are not dried within this time frame, mold growth may occur. Water-damaged porous materials cannot be adequately cleaned to remove mold growth. The application of a mildewcide to moldy porous materials is not recommended.

**Water Shooting over Bubbler Catch Basin over Carpet**

7. Place a plastic mat below the water bubbler. Reduce the water pressure to prevent the wetting of carpeting.
8. In order to maintain a good indoor air quality environment in the building, consideration should be given to adopting the US EPA document, “Tools for Schools”, which can be downloaded from the Internet at <http://www.epa.gov/iaq/schools/index.html>.
9. For further building-wide evaluations and advice on maintaining public buildings, see the resource manual and other related indoor air quality documents located on the MDPH’s website at <http://www.state.ma.us/dph/beha/iaq/iaqhome.htm>.
